ANVIL MINING CONGO SARL

DIKULUSHI COPPER SILVER PROJECT

ENVIRONMENTAL IMPACT ASSESSMENT

APRIL 2003

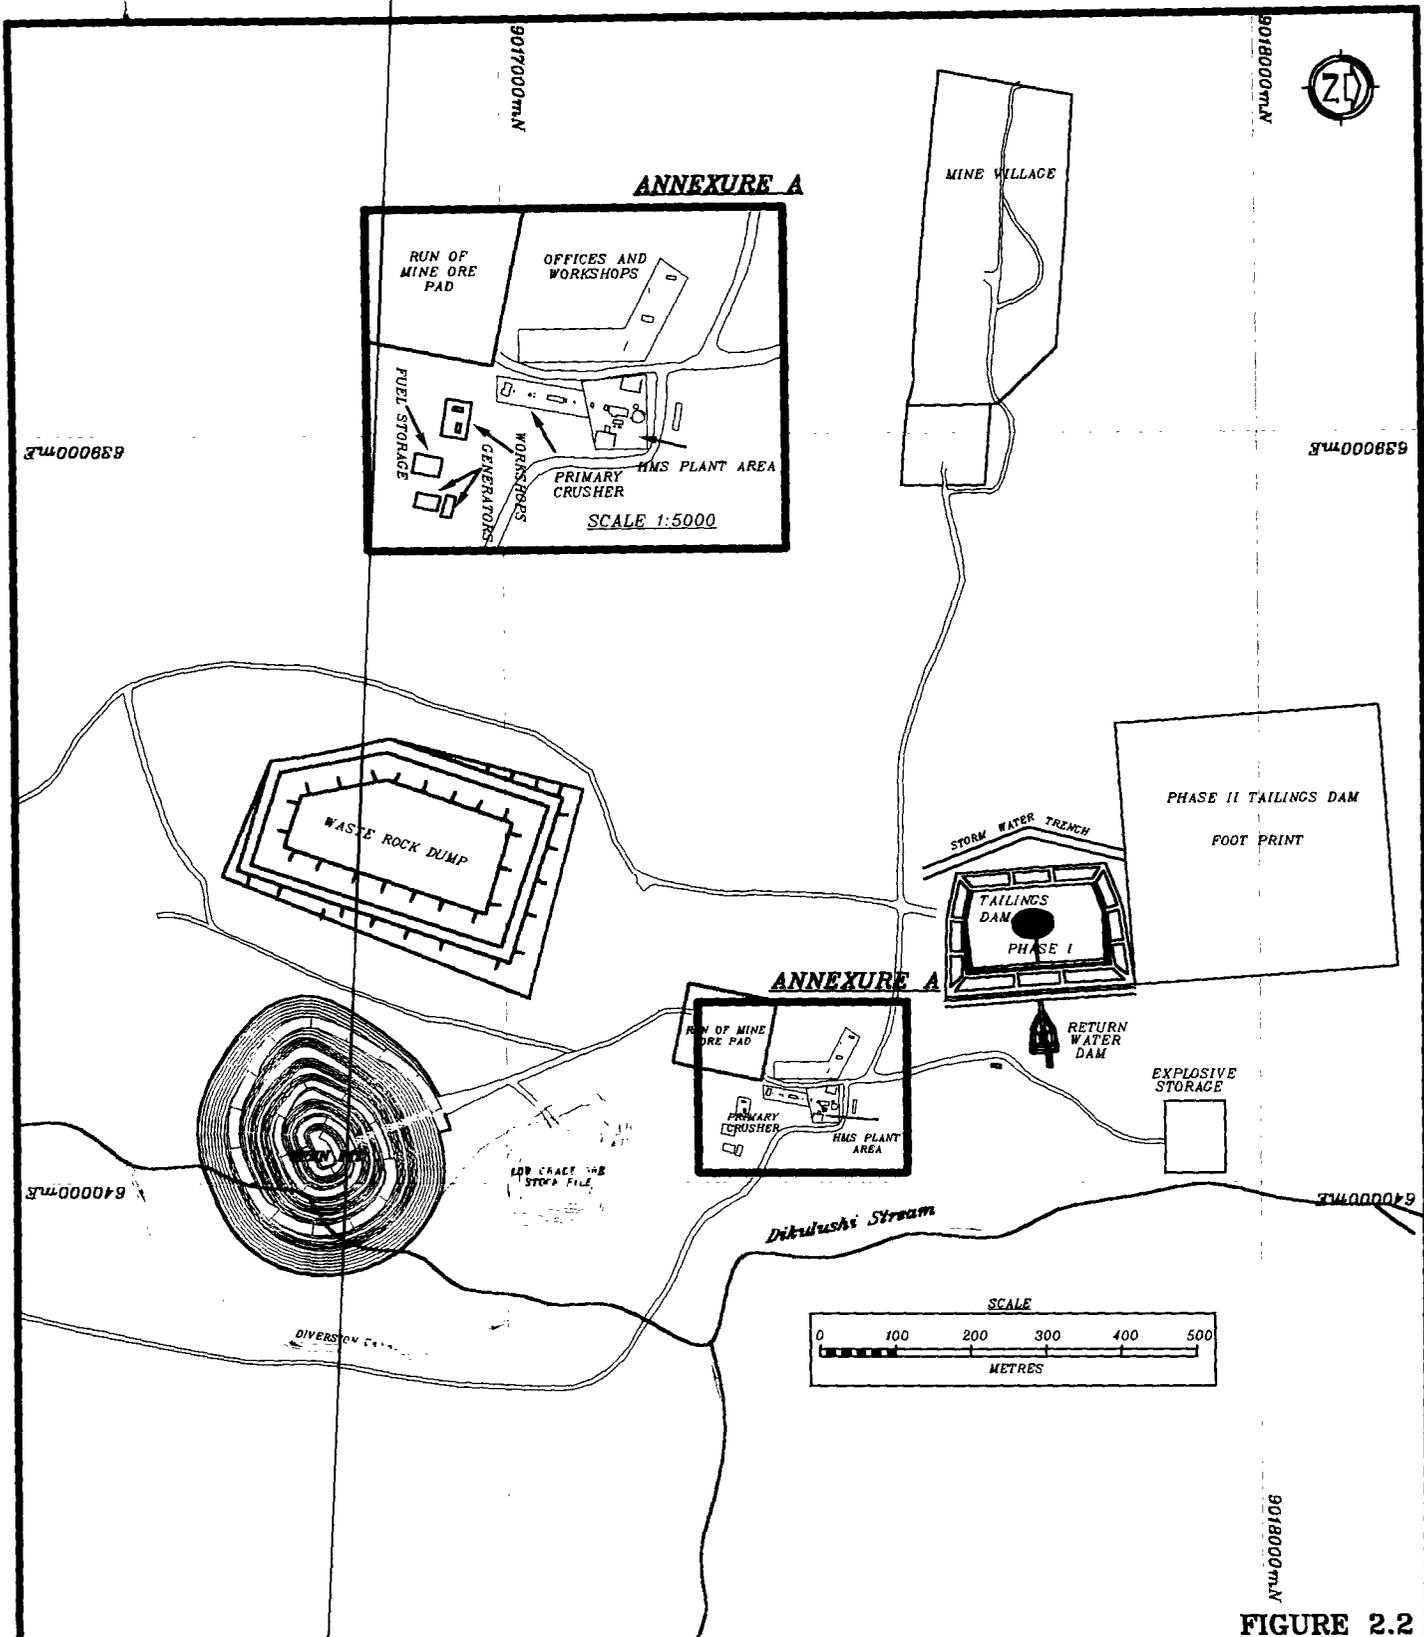
FIGURE 2.2

AFRICAN MINING CONSULTANTS LTD P.O BOX 20106, KITWE, ZAMBIA.		
PROJECT TITLE: DIKULUSHI ENVIRONMENTAL IMPACT ASSESSMENT DIKULUSHI MINE SITE PLAN		
SCALE 1 : 10000		
ORIGINATOR: A.S. K.M.	CLIENT: ANVIL MINING NL DWG NO: /../SITEPLAN.DWG	DATE: FEB 03 REV NO: 0

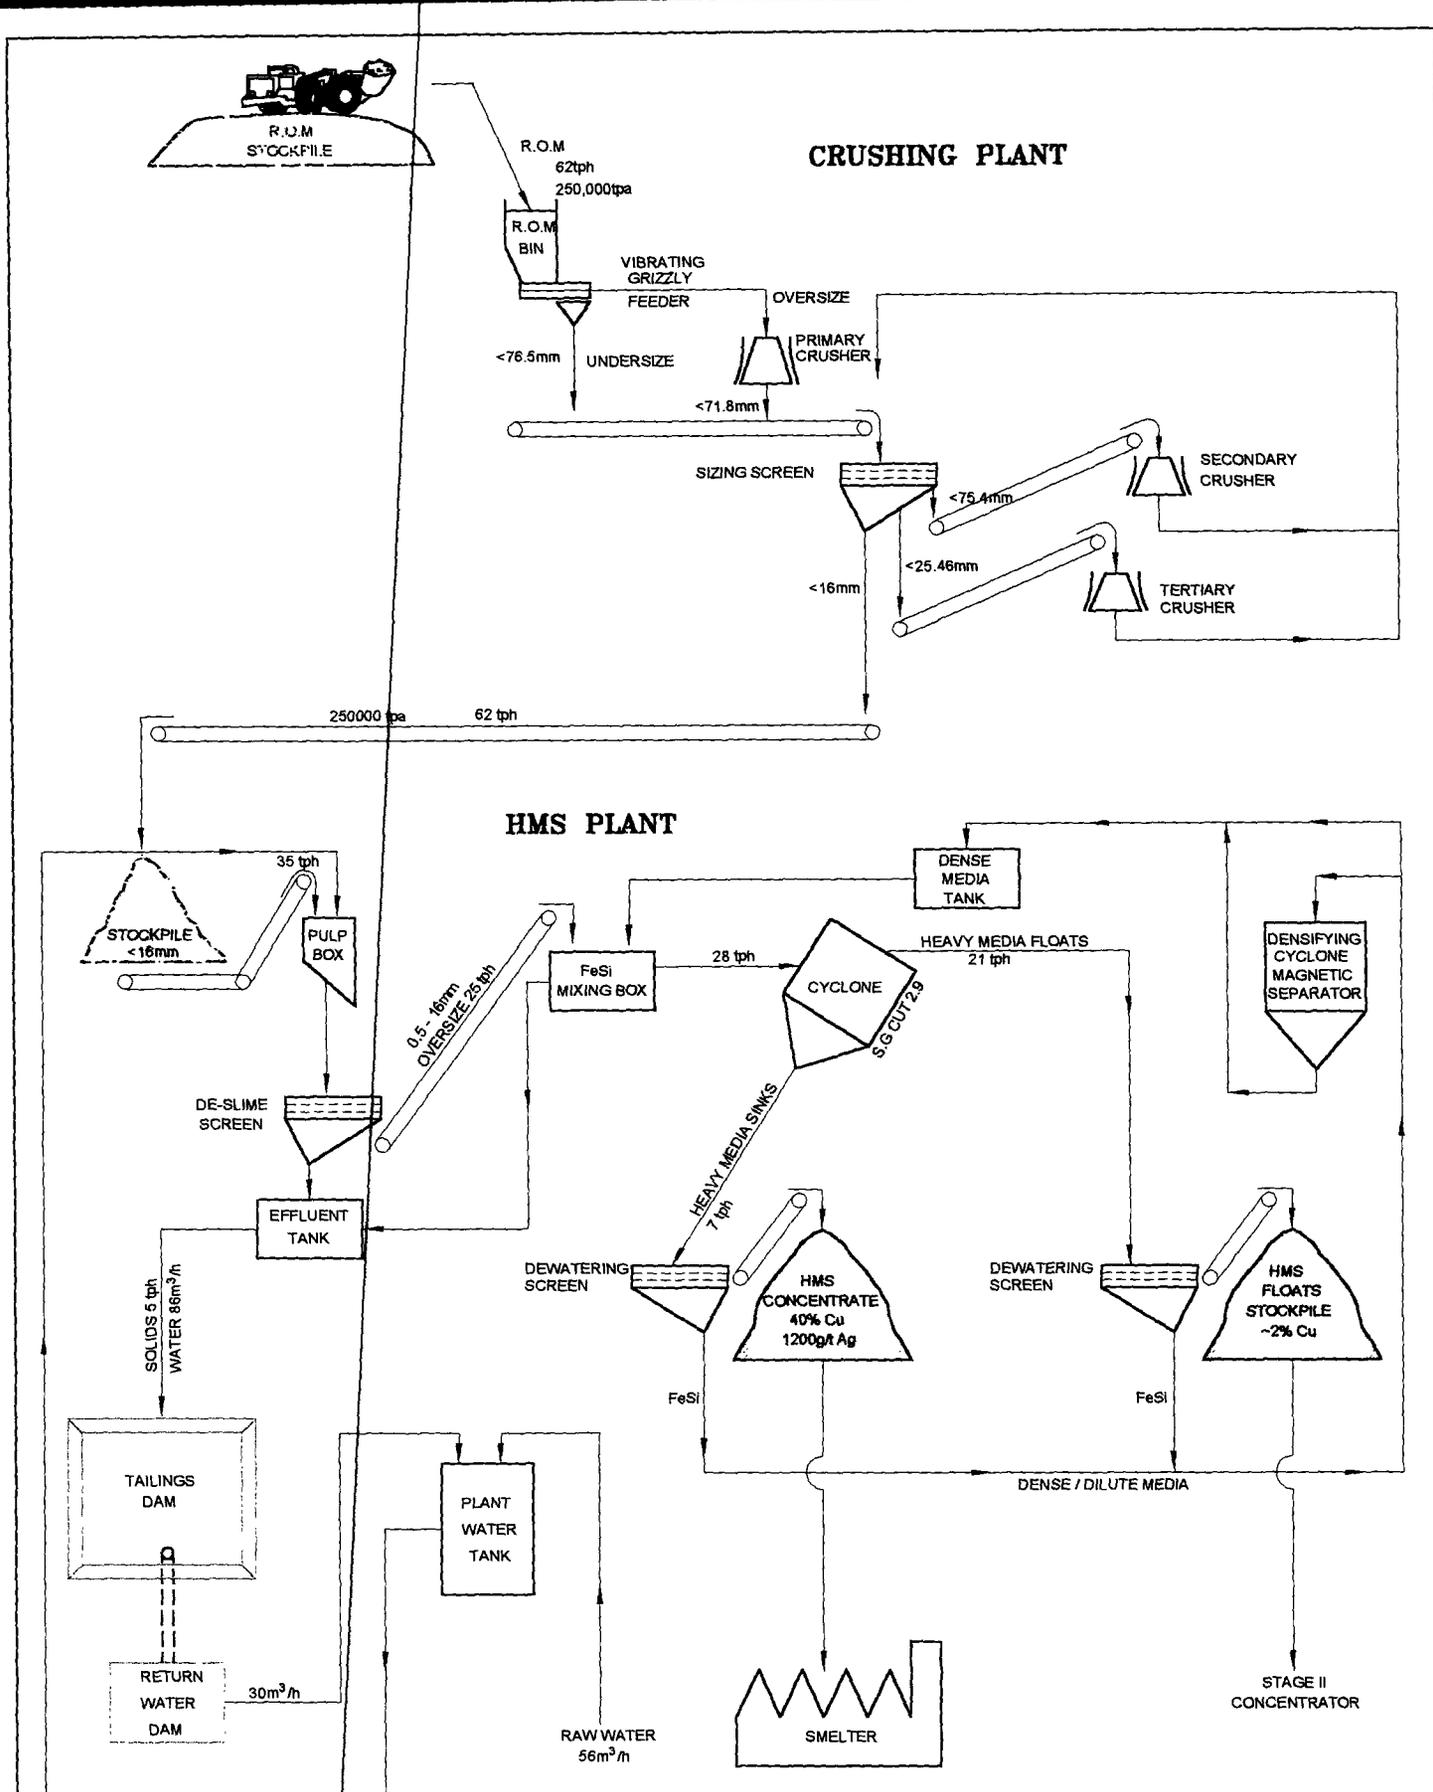
FIGURE 2.3a

The configuration of the crushing circuit and HMS plant is shown in Figure 2.3a. HMS feed is pulped and de-slimes on a vibrating screen. De-slimes oversize material is mixed with heavy media ferrosilicon (FeSi) and pumped to a separation cyclone. De-slimes screen undersize gravitates to the effluent tank and is pumped to the tailings dam.

AFRICAN MINING CONSULTANTS LTD P.O. BOX 20106, KITWE, ZAMBIA.		
PROJECT TITLE: DIKULUSHI ENVIRONMENTAL IMPACT ASSESSMENT PHASE I - HEAVY MEDIA SEPARATION PLANT HMS PROCESS FLOW DIAGRAM		
ORIGINATOR : AQS FPM		SCALE : NTS
CLIENT : ANML MINING NL FILE NAME : FLOWCHART1.DWG		DATE : MAR '03 REV : 0

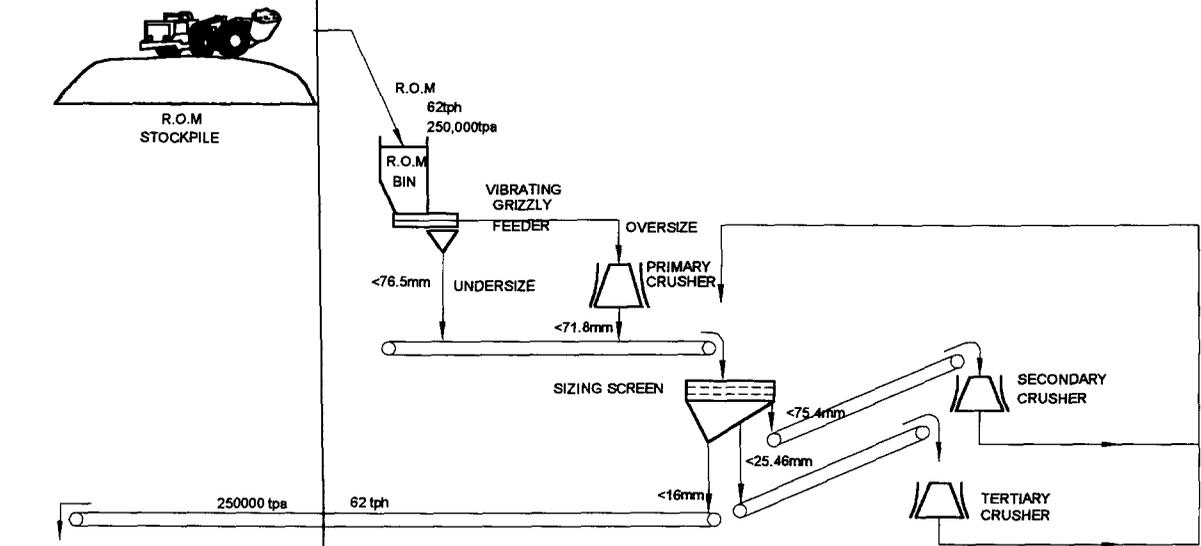
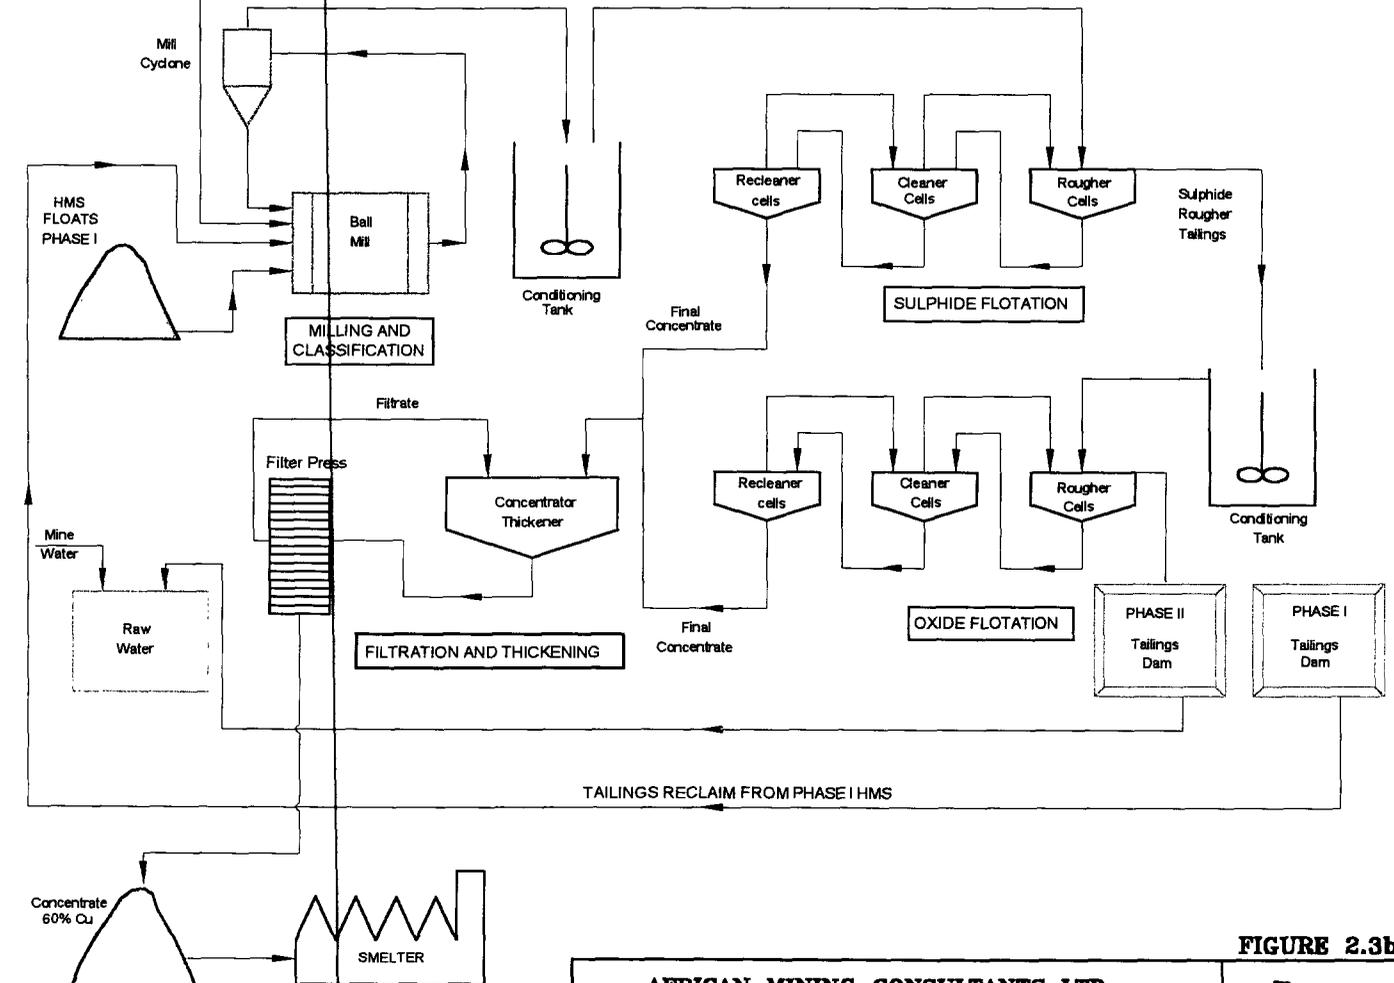
FIGURE 2.3b

Cyclone overflow is conditioned and then flows to the sulphide rougher cells. Rougher concentrate is pumped to the sulphide cleaner cells while rougher tailings are pumped to the oxide flotation circuit.

Sulphide rougher flotation tailings are fed to oxide flotation circuit conditioning tanks. Conditioned pulp gravitates to the oxide rougher cells. Rougher concentrate is pumped to the oxide cleaner cells and rougher tailings are pumped to the tailings dam.

The settling of copper concentrate in the concentrate thickener is assisted by the addition of flocculant. Thickened concentrate is further de-watered in a filter press. Filtrate is returned to the thickener feed. The concentrate product (60% Cu) is stockpiled awaiting shipment to a smelter.

AFRICAN MINING CONSULTANTS LTD P.O BOX 20106, KITWE, ZAMBIA.			
PROJECT TITLE: DIKULUSHI ENVIRONMENTAL IMPACT ASSESSMENT PHASE II - CONCENTRATOR PROCESS FLOW DIAGRAM			
ORIGINATOR : MEF DRAWN : DKM		CLIENT: ANML MINING NL FILE NAME: flowchart2	
DATE: DEC'02 REV: 0		SCALE :

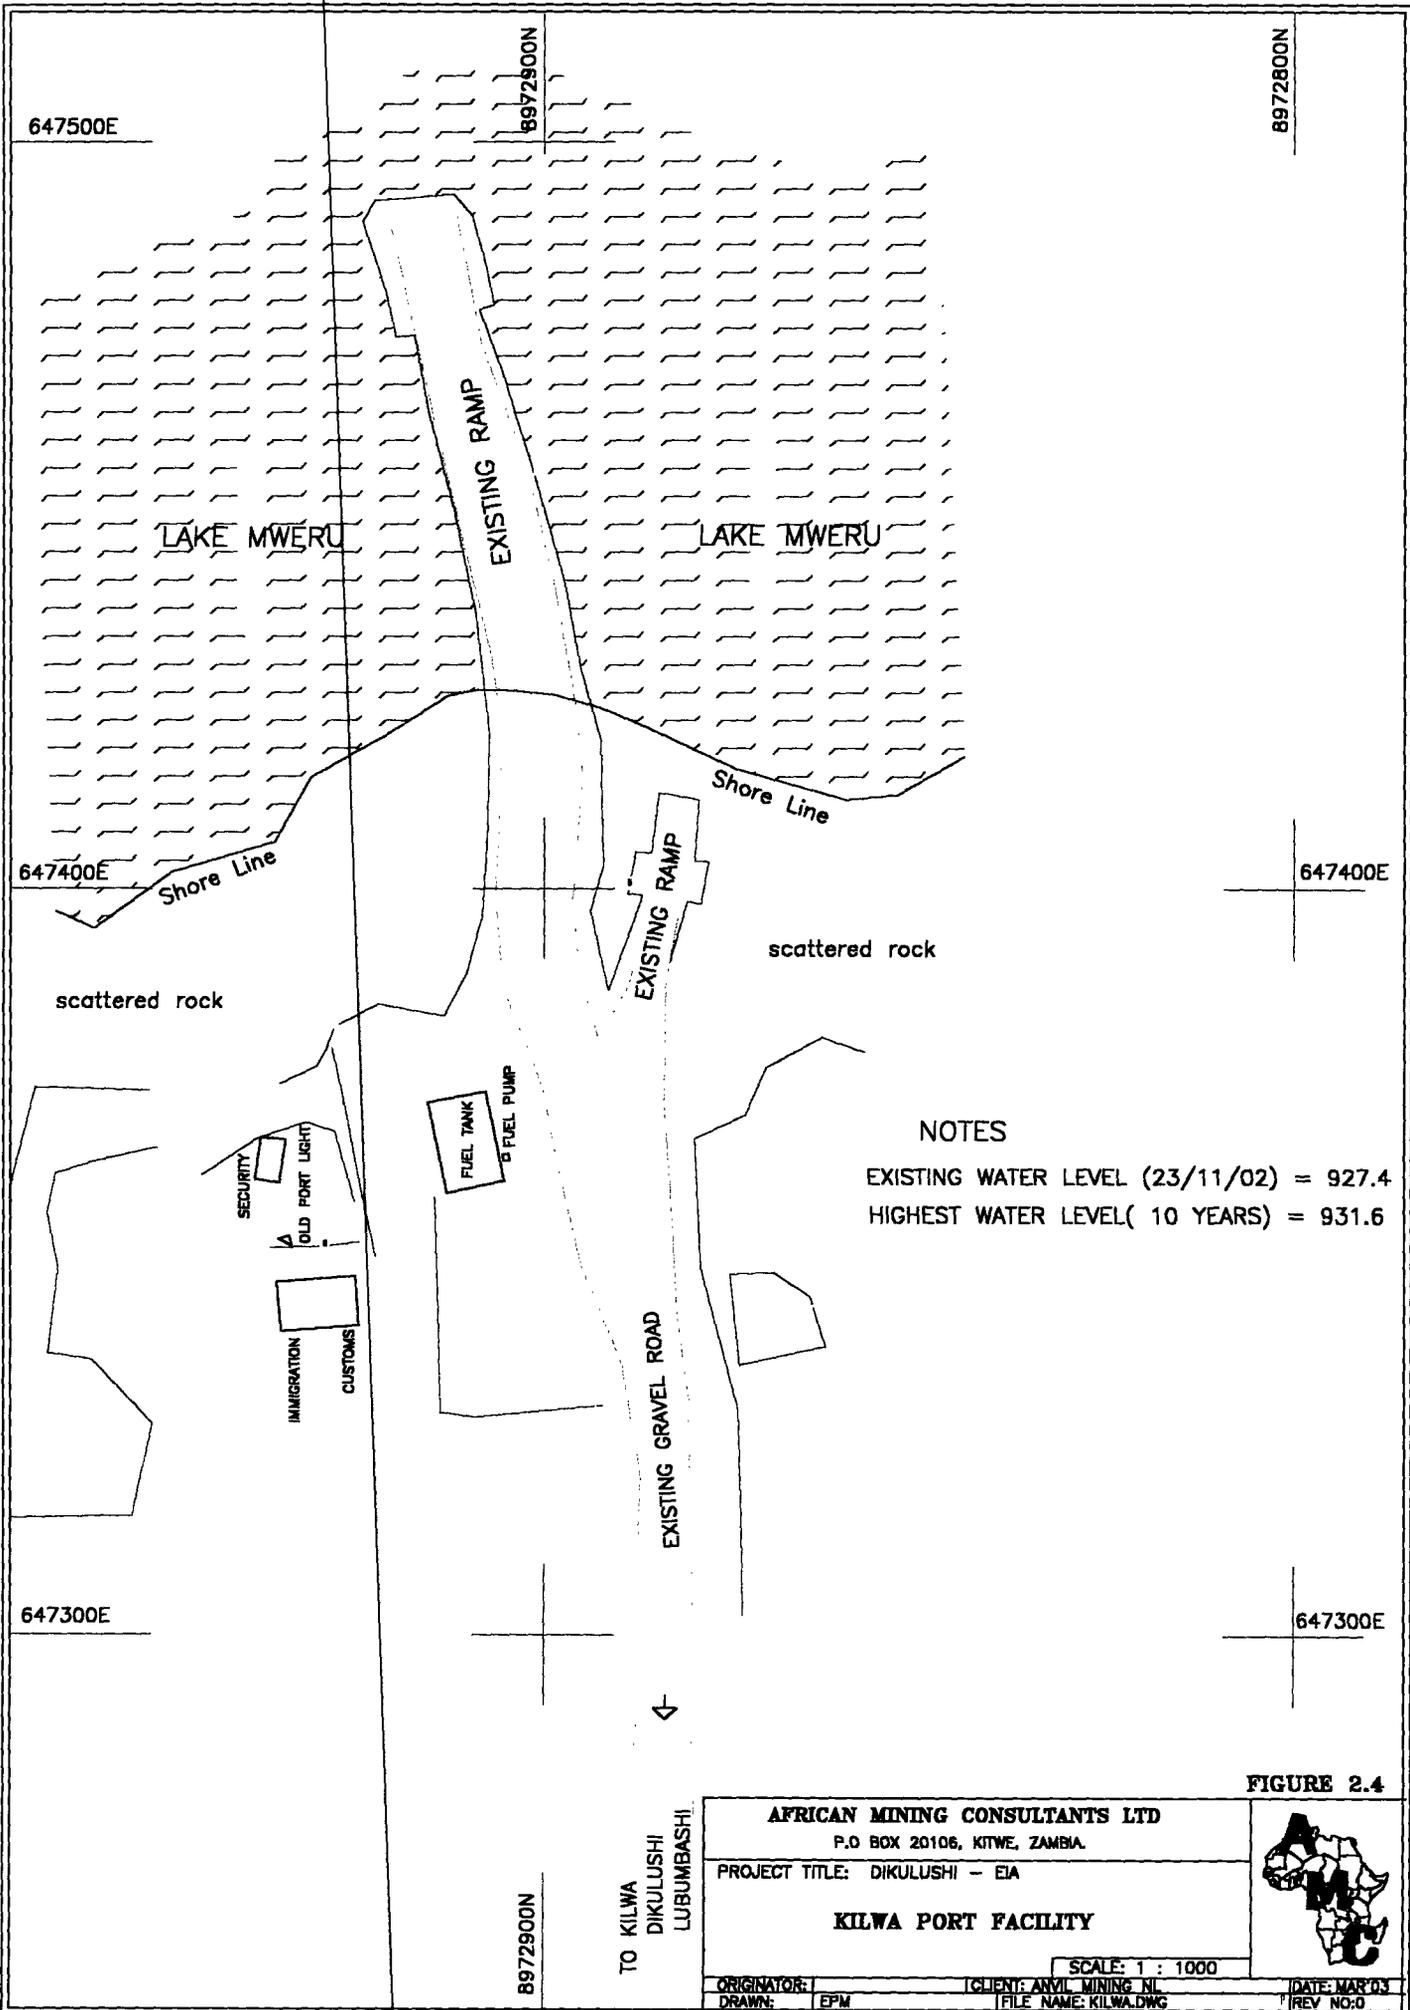
FIGURE 2.4

NOTES
 EXISTING WATER LEVEL (23/11/02) = 927.4
 HIGHEST WATER LEVEL(10 YEARS) = 931.6

Starting in 2003 the HMS concentrate will be transported to Kilwa in 1.5 tonne bulker bags. These will be off-loaded directly onto the barge for bulk shipment to Nchelenge. At Nchelenge, the concentrate will be off loaded and stored in a covered, 500 tonne capacity concentrate storage shed before onward shipment to smelters. During the bulk shipment phase the barge will ship concentrate every second day because of the increased payload when using bulker bags.

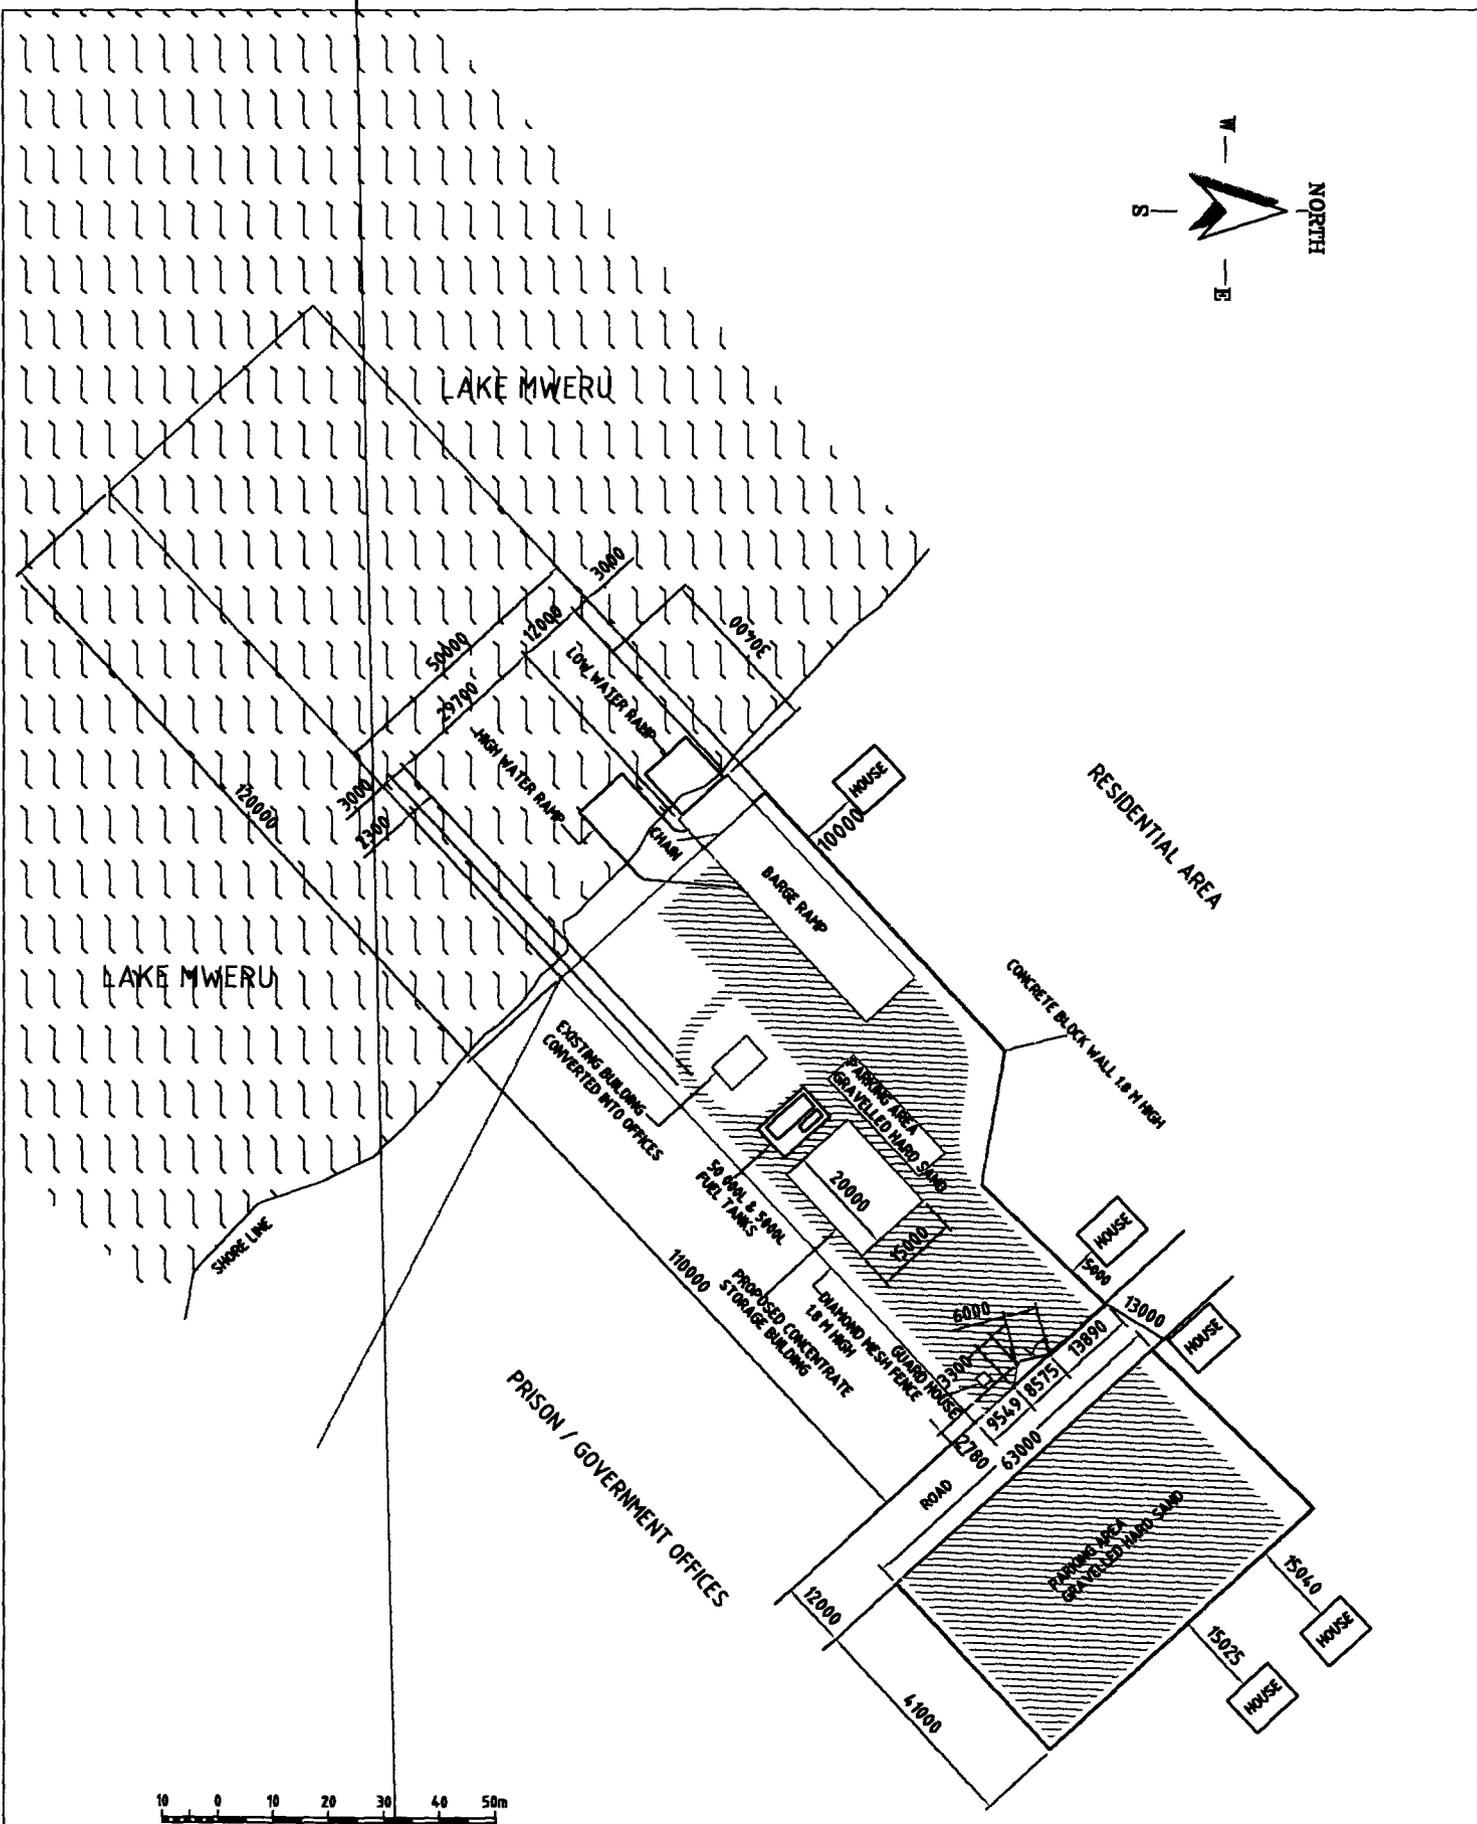
FIGURE 2.5

The Nchelenge Port facility is located in Nchelenge Town on the eastern shore of Lake Mweru. A general arrangement drawing of the Nchelenge Port Facility can be found in Figure 2.5. The total area of the port is approximately 1.4 ha. The port comprises a concrete ramp and two permanent jetties, an office, Exxon-Mobil owned fuel storage facility, gravel driveway and truck parking area. A covered shed for the storage of concentrate is planned, although this may now be sited at another location away from populated areas of Nchelenge.

AFRICAN MINING CONSULTANTS LTD P.O BOX 20106, KITWE, ZAMBIA.		
PROJECT TITLE: DIKULUSHI - EIA		
NCHELENGE PORT FACILITY		
ORIGINATOR:	CLIENT: ANYL MINING NL	SCALE: AS SHOWN
DRAWN: EPM	DATE: MAR'03

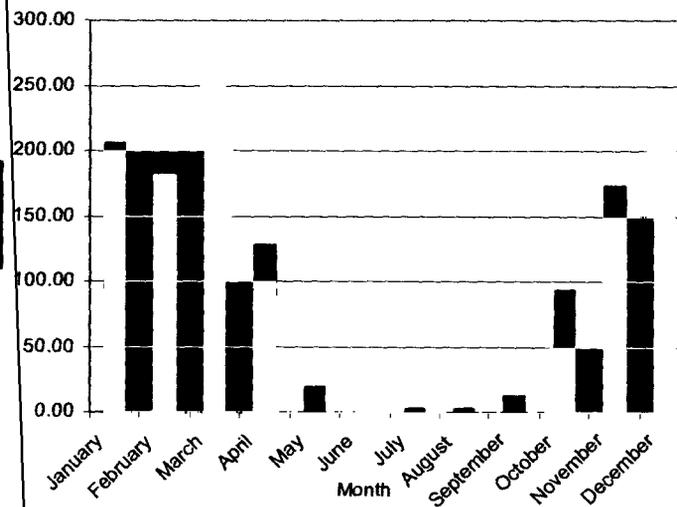
Figure 3.1 Monthly average rainfall, Kawambwa 1970 - 2000. (Meteorological Department, Zambia).

Kawambwa lies at a similar altitude to the Dikulushi mine site. Meteorological data for the years 1970 to 2000 indicates mean annual rainfall to be 1322mm, with annual maxima and minima of 1664mm and 1004mm respectively. The maximum 24 hour rainfall event was 114 mm. It should be noted that the data differs significantly from the Kilwa records.

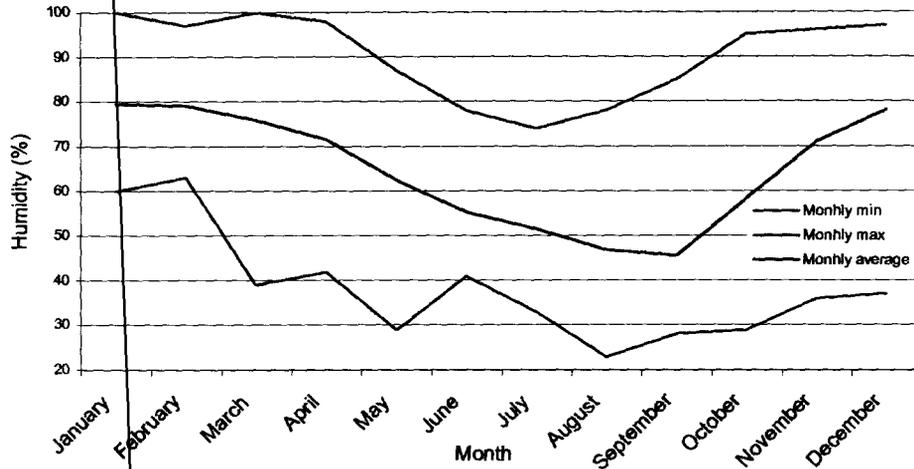
Humidity varies from a minimum of 23% in the dry season to a maximum of almost 100% in the wet season. Monthly average, maximum and minimum humidity is presented in Figure 3.2.

Figure 3.2 Relative humidity, Kawambwa 1970 – 2000 (Meteorological Department, Zambia)

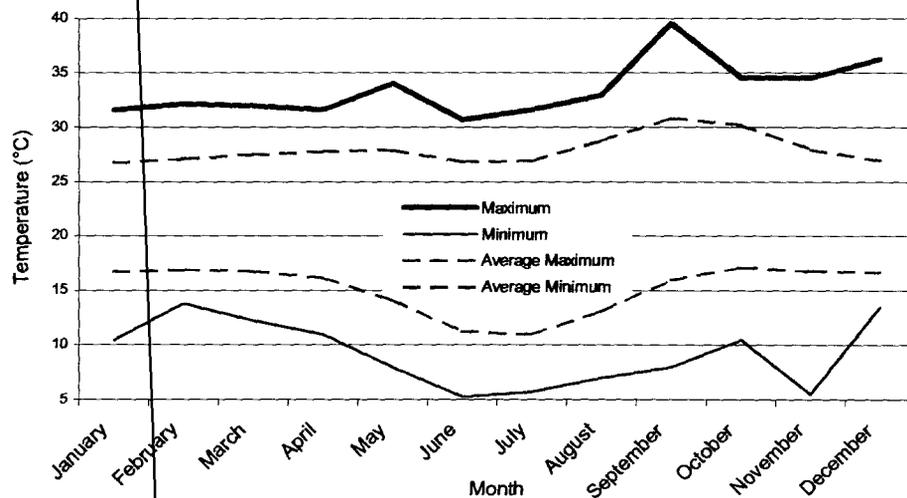
Temperature data for Kawambwa indicates that the warmest period is immediately prior to the wet season. Monthly minimum and maximum temperatures vary between 5°C and 31°C in June, at the height of the dry season, whilst temperatures may only vary between 14°C and 32 °C in February, a typical wet season month. Maximum recorded temperature in Kawambwa is 39.6°C (September) and minimum recorded temperature 5.3°C (June). Temperature data is presented in Figure 3.3.

Figure 3.3 Monthly Minimum and Maximum Temperature, Kawambwa 1970 – 2000 (Meteorological Department, Zambia).

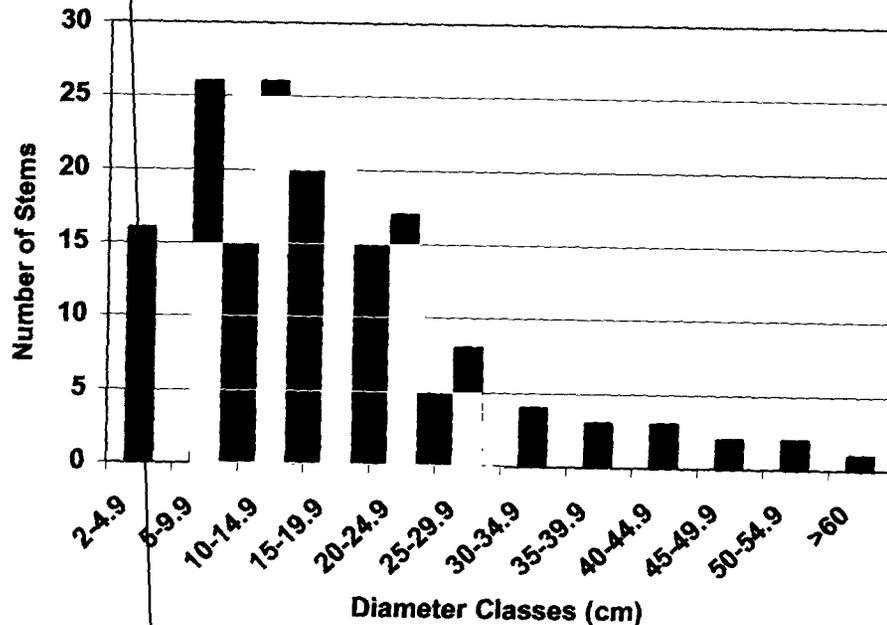
Diameter distributions are important for determining stages of growth for woodlands, regeneration and timber extraction potential. The bar graph presented in Figure 3.7 indicates that most species encountered were in the smaller diameter classes. This may be due to various factors including fire and historical land use activities by local people in the area.

Figure 3.7 General diameter bar chart based on tree diameters measured for all plots sampled during the vegetation survey.

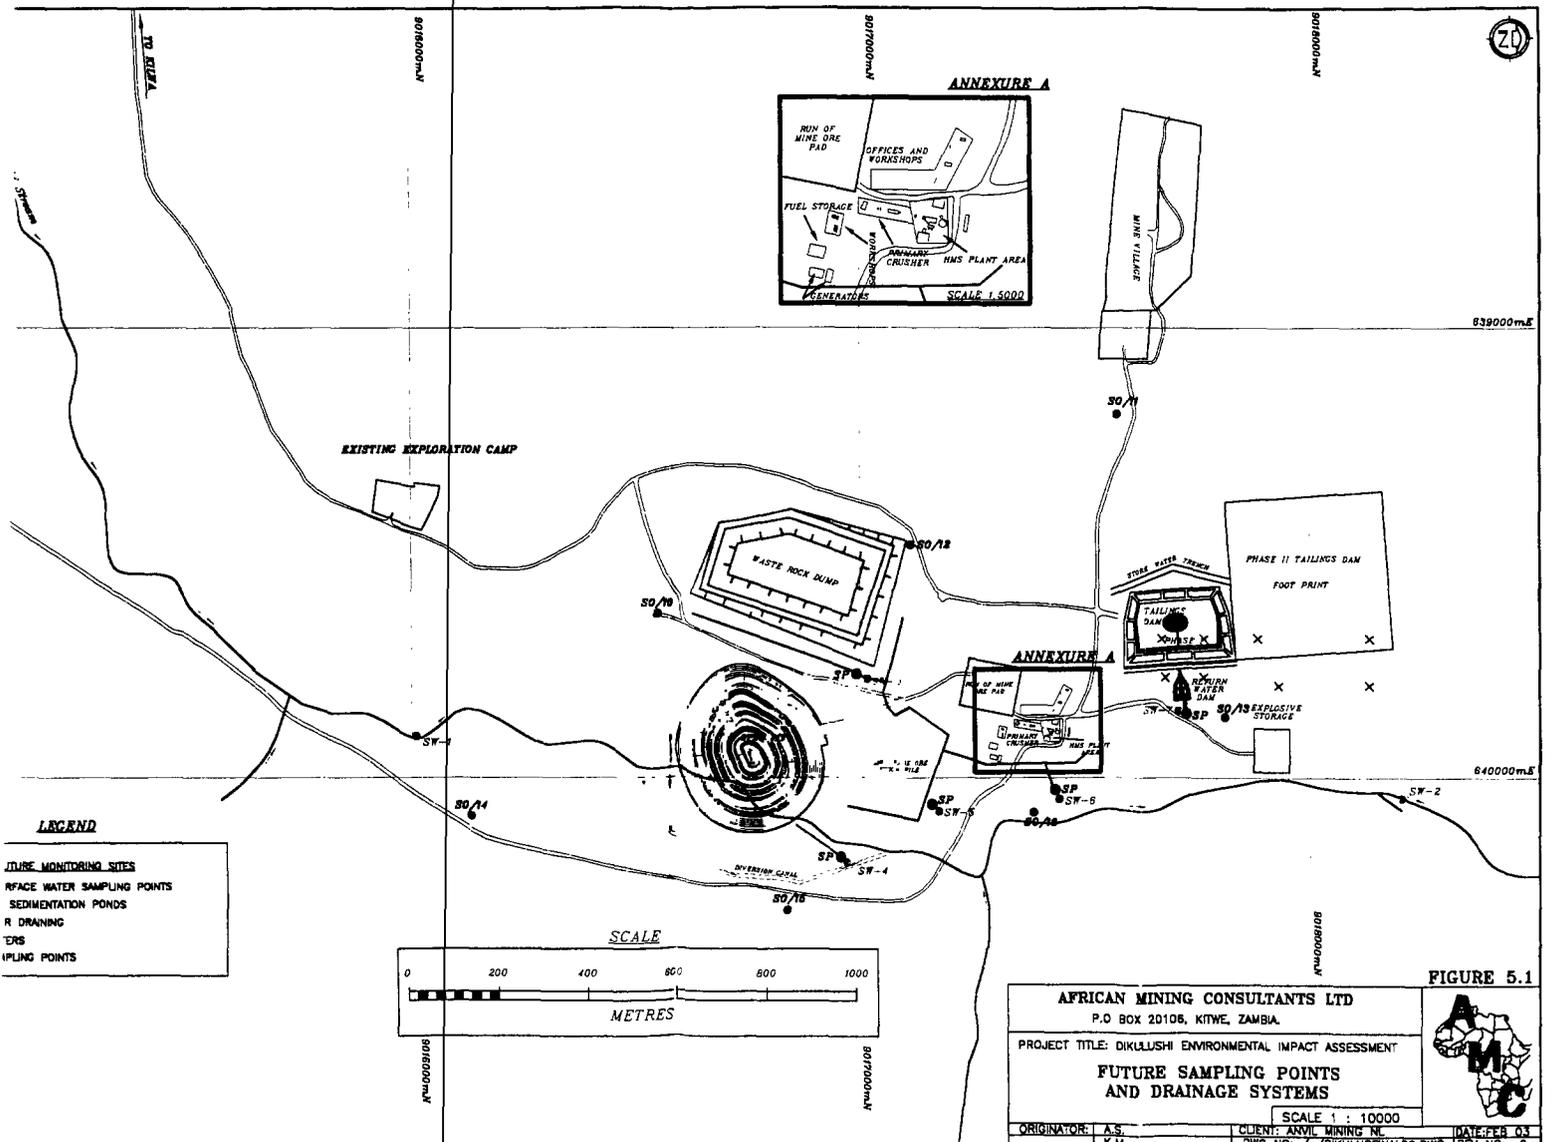
To control/prevent potentially contaminated water from entering surface water courses additional drains will be constructed around mine dumps and plant components as shown in Figure 5.1. All drainage systems will discharge into a sedimentation pond or series of cascading sedimentation ponds. The sedimentation ponds will be designed with sufficient volume to allow settling to occur before water is discharged into the Dikulushi River. Resulting discharge will be monitored and treated if necessary as

outlined in the non-compliance procedures. All drains and sedimentation ponds will be regularly inspected and maintained to ensure that they are operating efficiently and are clear of solids.
